NEWPORT LAKES PRIMARY SCHOOL
40 ELIZABETH STREET NEWPORT

ARBORICULTURAL REPORT

JULY 2020

AUSTRALIAN TREE CARE

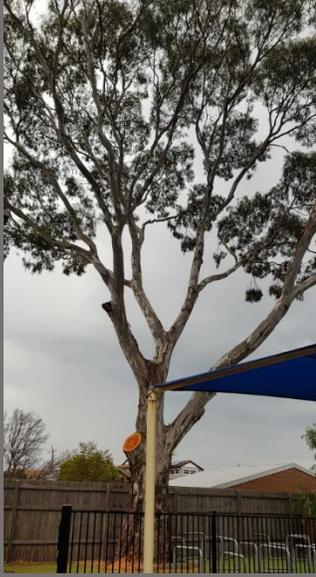
Tree #1

ID	<i>Eucalyptus camaldulensis</i>	
Stem Diameter at 1.5 m (cm)	123	
Height x Width (metres)	16 x 18	
TreeAZ	Z9	
Comment	Fungal fruiting bodies attached to tree which indicates the decay is present within the stems.	
Recommendations	Remove tree	
Priority	HIGH	
Tree #2

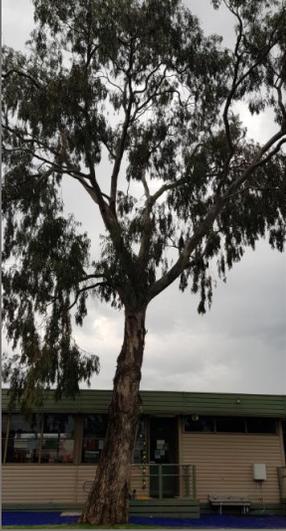
ID	<i>Eucalyptus camaldulensis</i>	
Stem Diameter at 1.5 m (cm)	87	
Height x Width (metres)	14 x 14	
TreeAZ	Z9	
Comment	Fungal fruiting bodies attached to tree which indicates the decay is present within the stems.	
Recommendations	Remove tree	
Priority	HIGH

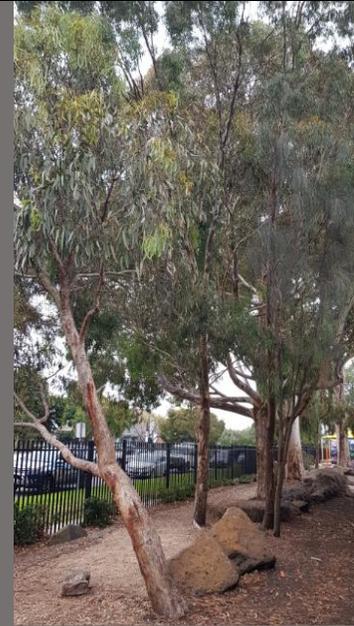
Group #3

ID	Mixed native species
Stem Diameter at 1.5 m (cm)	NA
Height x Width (metres)	4-8 x 2-6
TreeAZ	Z1
Comment	
Recommendations	<p>Clear foliage from buildings and fence</p> <p>Remove stems with acute unions</p>
Priority	LOW

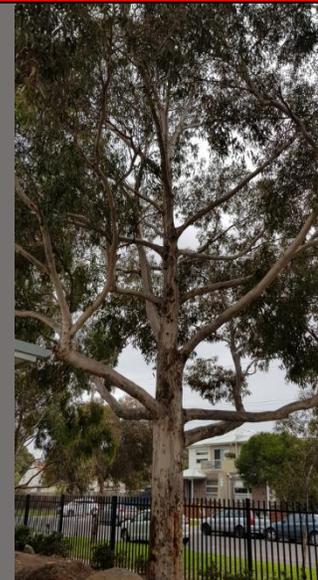
Tree #4

ID	<i>Eucalyptus cladocalyx</i>
Stem Diameter at 1.5 m (cm)	50
Height x Width (metres)	12 x 12
TreeAZ	A2
Comment	Branches becoming elongated and tip heavy
Recommendations	Reduce stem end weight by approximately 10%
Priority	HIGH

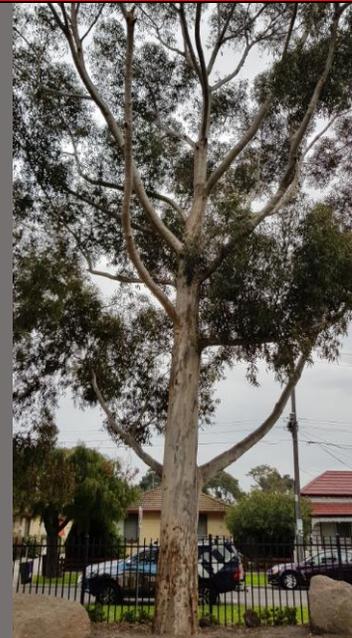
Tree #5

ID	<i>Eucalyptus cladocalyx</i>
Stem Diameter at 1.5 m (cm)	67
Height x Width (metres)	14 x 14
TreeAZ	A2
Comment	Branches becoming elongated and tip heavy
Recommendations	Reduce stem end weight by approximately 10%
Priority	HIGH

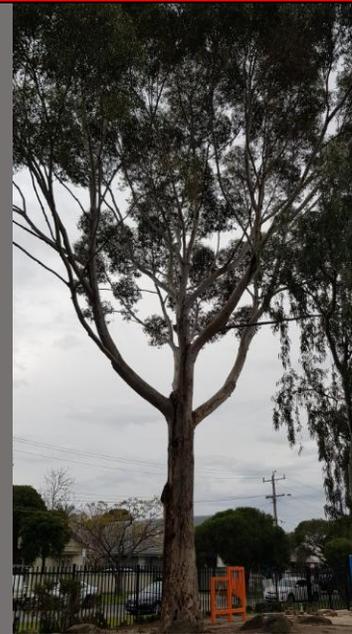
Tree #6

ID	<i>Eucalyptus cladocalyx</i>
Stem Diameter at 1.5 m (cm)	84
Height x Width (metres)	16 x 12
TreeAZ	A2
Comment	Branches becoming elongated and tip heavy
Recommendations	Reduce stem end weight by approximately 10% Prune deadwood from canopy
Priority	HIGH

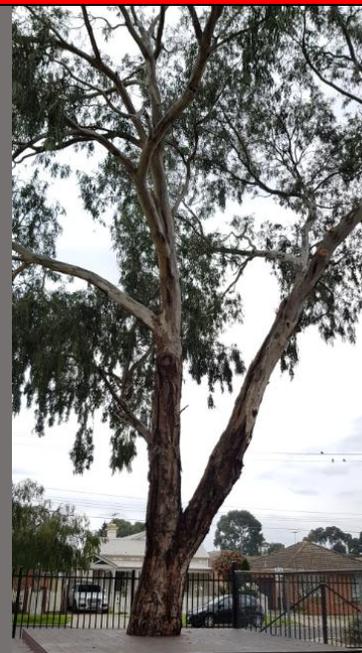
Tree #8

ID	<i>Eucalyptus camaldulensis</i>
Stem Diameter at 1.5 m (cm)	100
Height x Width (metres)	16 x 18
TreeAZ	Z9
Comment	Tree is actively splitting at its main union Weight of stem failure is supported by a small diameter cable
Recommendations	Remove (URGENT)
Priority	HIGH

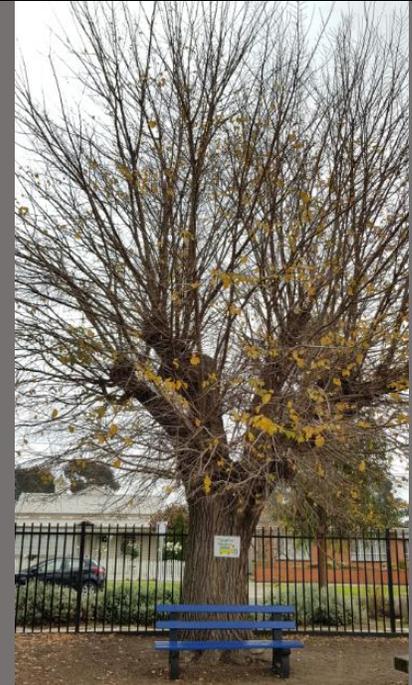
Tree #9

ID	<i>Ulmus parvifolia</i>
Stem Diameter at 1.5 m (cm)	90
Height x Width (metres)	8 x 8
TreeAZ	A2
Comment	Tree has been lopped in the past Canopy consists of epicormic regrowth
Recommendations	Pollard tree/ or remove the smaller less dominant stems and allow for the larger better limbs to dominate the canopy
Priority	LOW

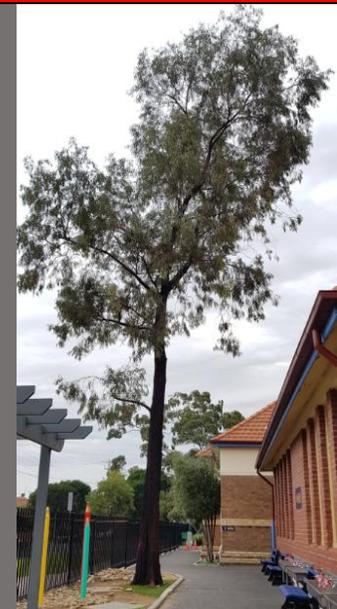
Tree #10

ID	<i>Eucalyptus sideroxylon</i>
Stem Diameter at 1.5 m (cm)	53
Height x Width (metres)	18 x 10
TreeAZ	A2
Comment	Branches becoming elongated and tip heavy
Recommendations	Reduce stem end weight by approximately 10%
Priority	HIGH

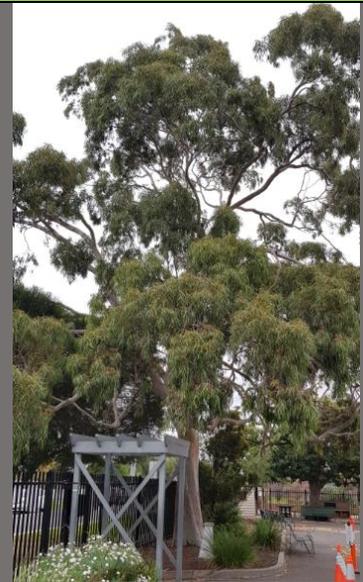
Tree #11

ID	<i>Corymbia citriodora</i>
Stem Diameter at 1.5 m (cm)	65
Height x Width (metres)	14 x 12
TreeAZ	A2
Comment	Branches becoming elongated and tip heavy
Recommendations	Reduce stem end weight by approximately 10%
Priority	LOW

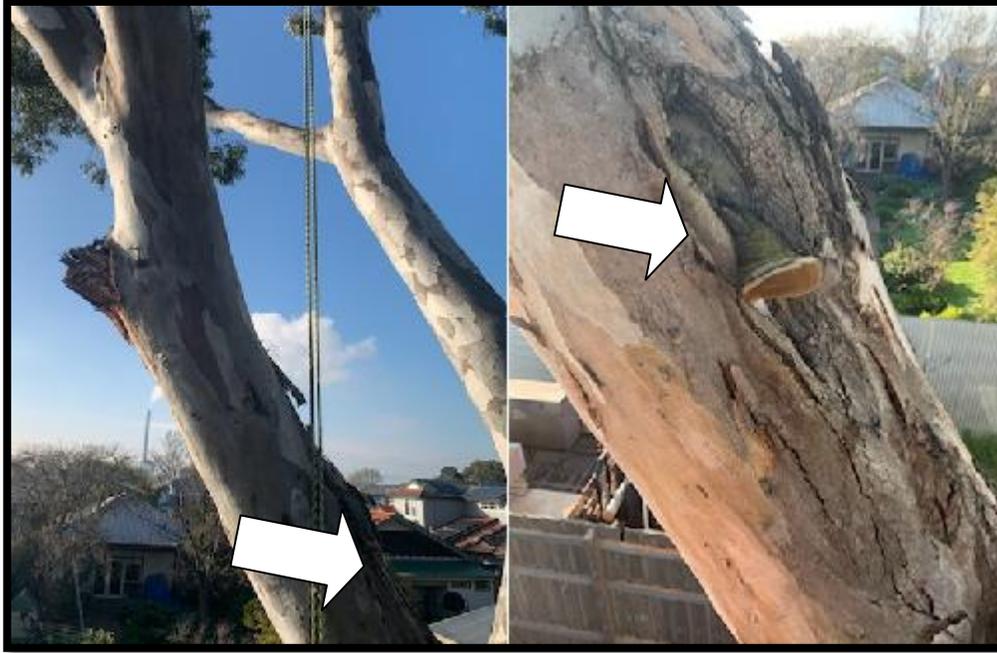
The *Eucalyptus camaldulensis* River Red Gum can be prone to brown rot decay which eventually results in stem loss. This can occur during stormy weather, high wind or on a normal day. The Red Gums on the site have been assessed for indications of decay and it was found to be present (Tree #1 & Tree #2).

Figure 1 - (Tree #1) Fungal fruiting bodies which indicate the presence of decay

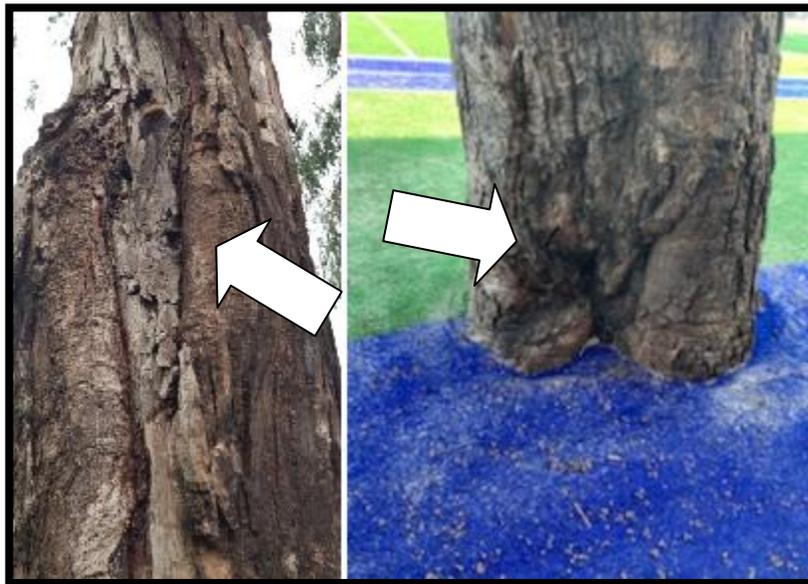
Figure 2 - (Tree #2) Fungal fruiting body is located within a wound face on the main stem. There is also dieback at the base

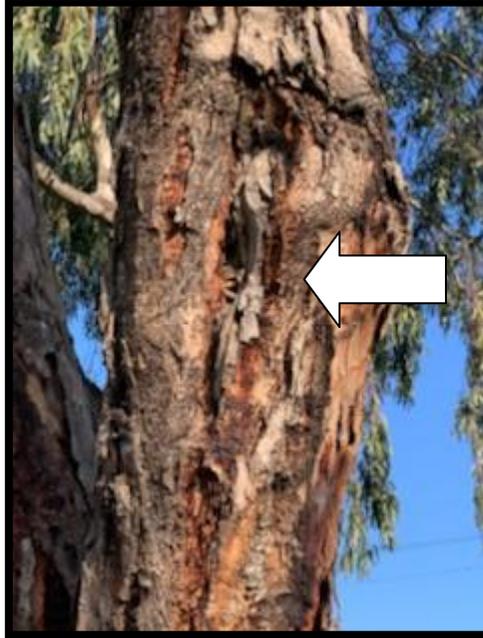
Figure 3 - (Tree #8) Decay is present within one of the stems of the tree

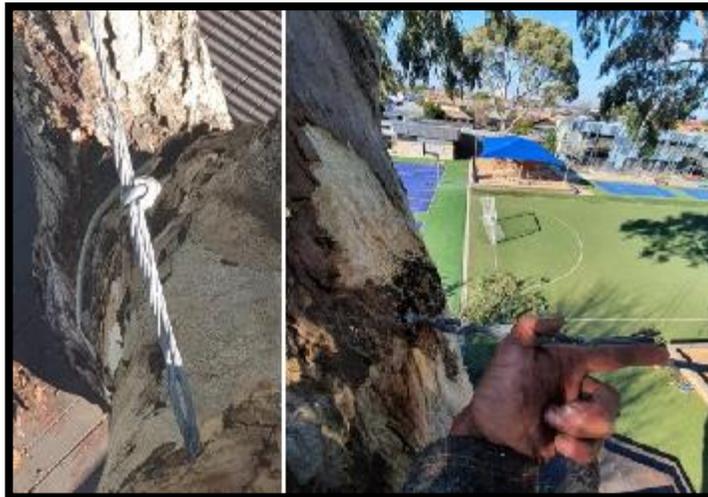
Assessment of Tree #8 found that the main stem is actively splitting and is only remaining intact due to a small diameter cable within the tree. The cable is insufficient for the size and weight material within the tree and is commonly installed to reduce stem movement during high winds and to catch fallen stems. In this situation the stem has failed and is rotating upon the cable during wind movement. While the tree is currently supported it is recommended that the tree be removed as urgently as possible as it is only a matter of time before the cable of stem fail completely.

Figure 4 - (Tree #8) Image on the right shows the splitting main stem with the small diameter cable in the foreground. The image on the right shows the cable diameter in perspective to our climber's finger. A cable of this size is insufficient to support the weight of this size tree
