NEWPORT LAKES PRIMARY SCHOOL
40 ELIZABETH STREET NEWPORT

ARBORICULTURAL REPORT

JULY 2020

AUSTRALIAN TREE CARE

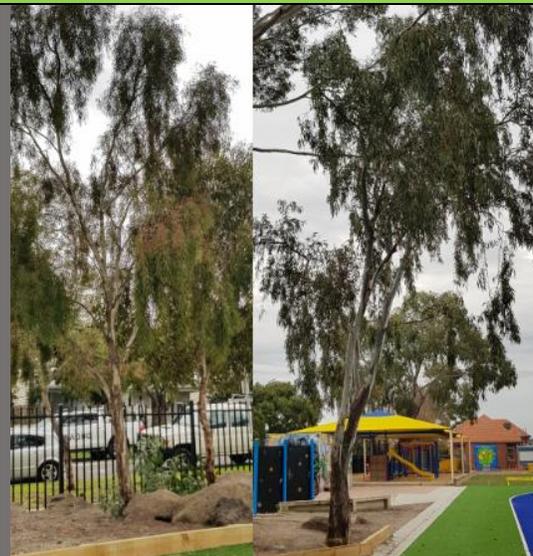
Tree #8

ID	<i>Eucalyptus camaldulensis</i>
Stem Diameter at 1.5 m (cm)	100
Height x Width (metres)	16 x 18
TreeAZ	Z9
Comment	Tree is actively splitting at its main union Weight of stem failure is supported by a small diameter cable
Recommendations	Remove (URGENT)
Priority	HIGH
